The above rock face/ wall and above photos are from a project that was completed at the Sydney suburb of Tempe for a bus depot extension. The design plans had nominated a concrib wall along the rock face. Although during the excavation it was observed the rock face was in good condition and would not require a retaining structure as previously defined. Before the excavation the wall was partly covered with spoil, shrubs and trees, hence it appeared the batter only had minor floating rocks in it. Once the rock face was discovered, a decision was made to delete the concrib wall, cut the wall face back and install rock bolts as assessed by a geotechnical engineer. Also, shotcreting works was undertaken at the top of the batter (which was at street level) as the material was not sound and would erode overtime, if not repaired.

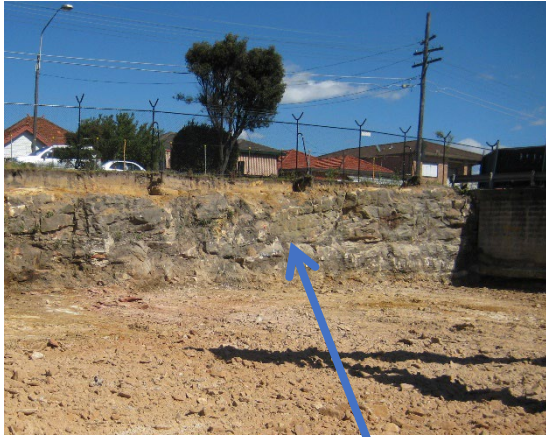
Rock face had to be cut back and stabilised to install hardstand area

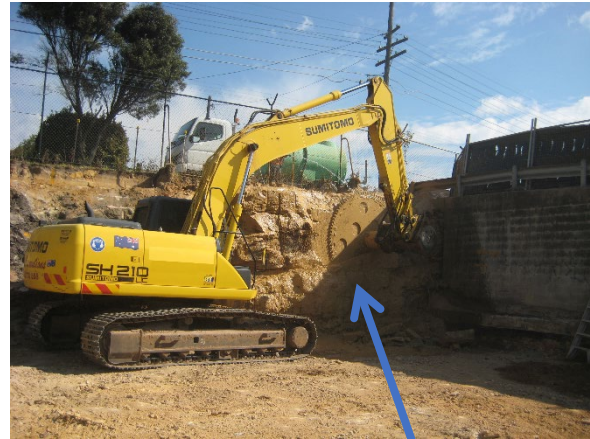
Rock Saw attachment was utilised to cut the sandstone face back

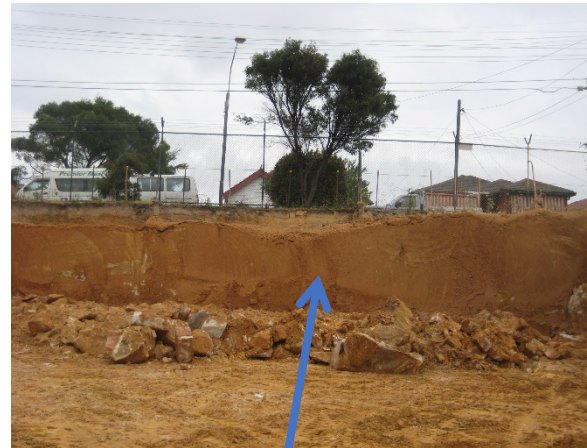
Sandstone Face after cutting complete

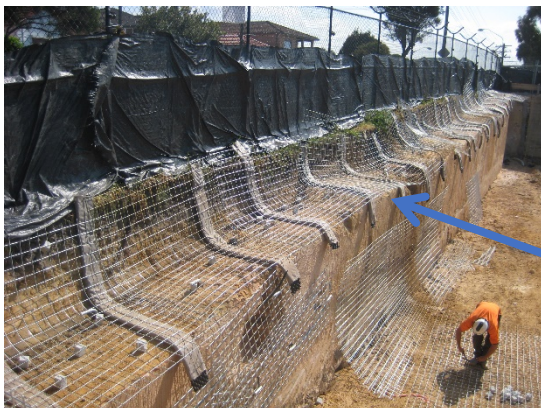
Shotcreting required at top of batter and minor rock bolting along face
